Mikoš, M., Majes, B. 2010. Mitigation of large landslides and debris flows in Slovenia, Europe. Landslides: Causes, Types and Effects: 105-131.

Chapter 3

MITIGATION OF LARGE LANDSLIDES AND DEBRIS FLOWS IN SLOVENIA, EUROPE

Matjaž Mikoš and Bojan Majes

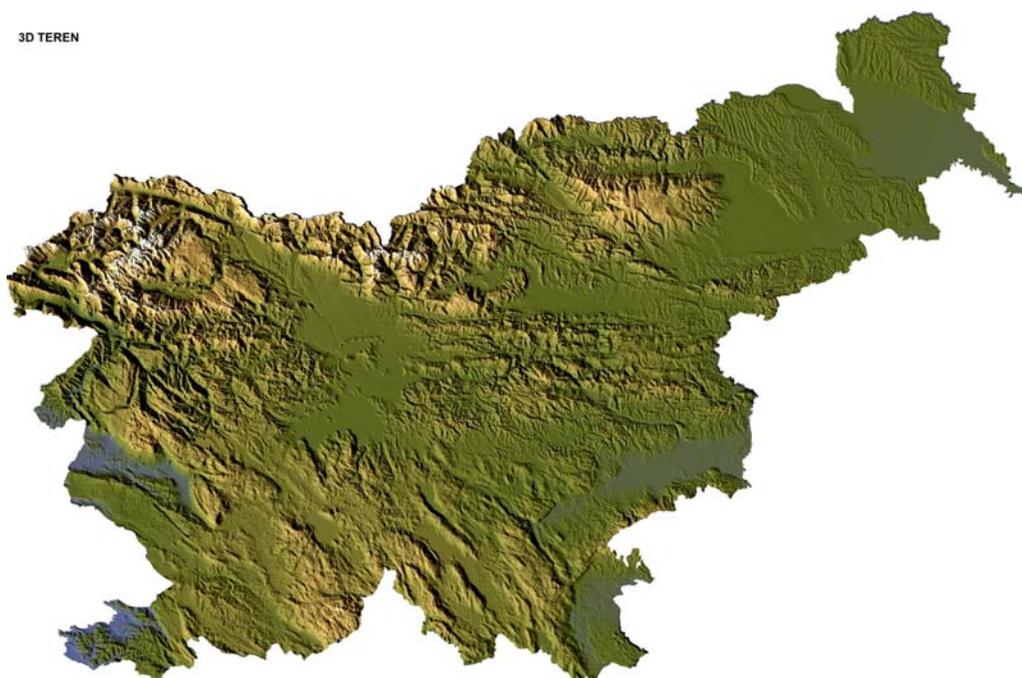
Figure 1. Relief map of Slovenia – 20,273 km² (from <http://ksh.fgg.uni-lj.si/ewnsi/>).

Slovenia is a mountainous and hilly country (Figure 1). Only 8.6% of its territory is areas with terrain inclination less than 4% (digital terrain model 20 x 20 m; SURS, 2007). The plain lowlands consist of very permeable alluvial gravel and sand deposits with large aquifers vulnerable to pollution. An important hydro-geological characteristic of Slovenia is that about 44% of its territory is karstic (Mikoš *et al.*, 2004a), characterized by special landforms and subsurface drainage. The karst region has low stream density, surface waters soon disappear underground, and reappear in strong karstic water sources, and the region occasionally suffers
